Site No. 9

STONE BRIDGE TIVERTON

Tiverton
State Route 77 (Main Road)

Site Description

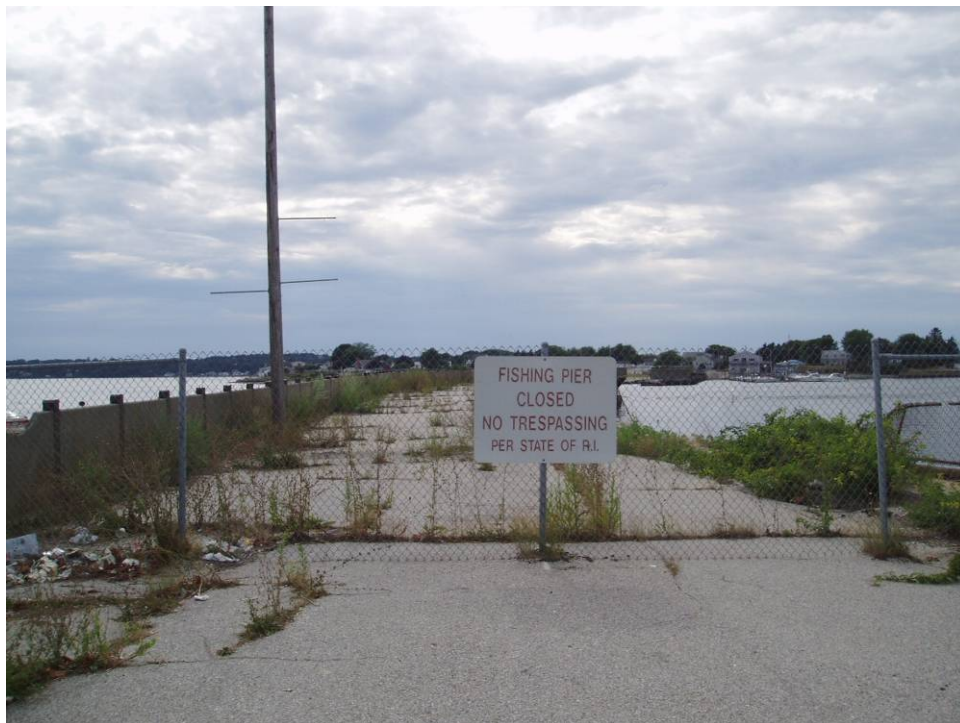
Photo 2. Trespassing notice at the Stone Bridge abutment. The fencing is easily bypassed through an opening along the southerly (left) bridge railing.

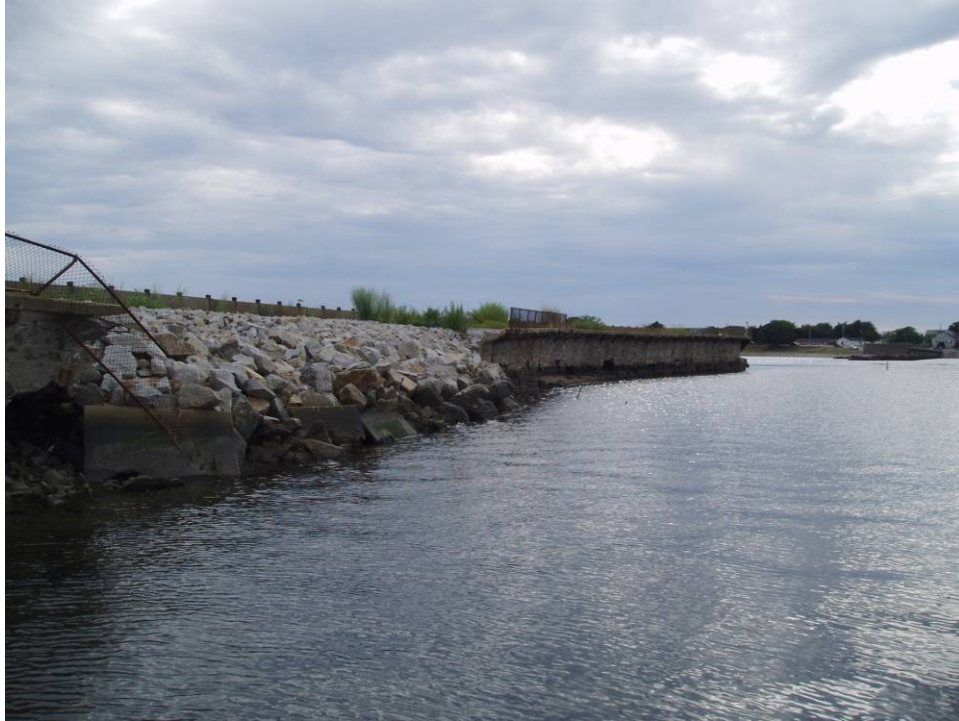
The most prominent feature of the Stone Bridge site is the existing masonry abutment, which along with the corresponding westerly abutment along the Middletown shoreline, defines the channel opening and provides protection for harbor uses to the north. As previously noted, this structure is in a deteriorating condition, currently fenced off to public access and posted for no trespassing (see Photos 2, 3). The partial failure of the northerly wingwall in 2000 (Photo 3) required the placement of a rip rap slope for temporary stabilization. Despite being posted for no trespassing, the abutment remains accessible through a narrow opening in the fence and is still occasionally used for fishing (as observed upon site visit). While structurally unsafe and in need of extensive rehabilitation, this structure offers good opportunity for casting along both sides near its channel end. The placement of armor stone along its westerly (channel) side effectively prohibits casting directly towards the boating channel from the abutment (Photo 9).

Photo 3. Failed section of northerly wingwall that has been stabilized
By the placement of rip rap.

The Stone Bridge Tiverton site could readily benefit from capital investment to bring the quality of its infrastructure to a level commensurate with the high quality of fishing offered at this location. This could ostensibly be achieved through rehabilitation of the east abutment for fishing use as well as improvements to the condition and aesthetics of existing Grinnell's Beach facilities. It is also important to note the integral role of the existing east abutment in the hydraulics of the waterway, as it currently protects municipal harbor, mooring, and shoreline uses to the north. As this structure recently experienced more significant deterioration (failure of the northerly wingwall in 2000), the Town of Tiverton has recognized the need for its structural rehabilitation or replacement. In 2004 the town solicited professional engineering services to develop a preliminary design and cost estimate for this work; through this study it was determined that the estimated cost to rehabilitate of the Stone Bridge abutment structure is in the range of 2 million dollars. While the town has secured some grant monies for this work, currently available funds are well below the amount required to the satisfactorily rehabilitate the east abutment. Accordingly, plans for development have been temporarily deferred at this time.

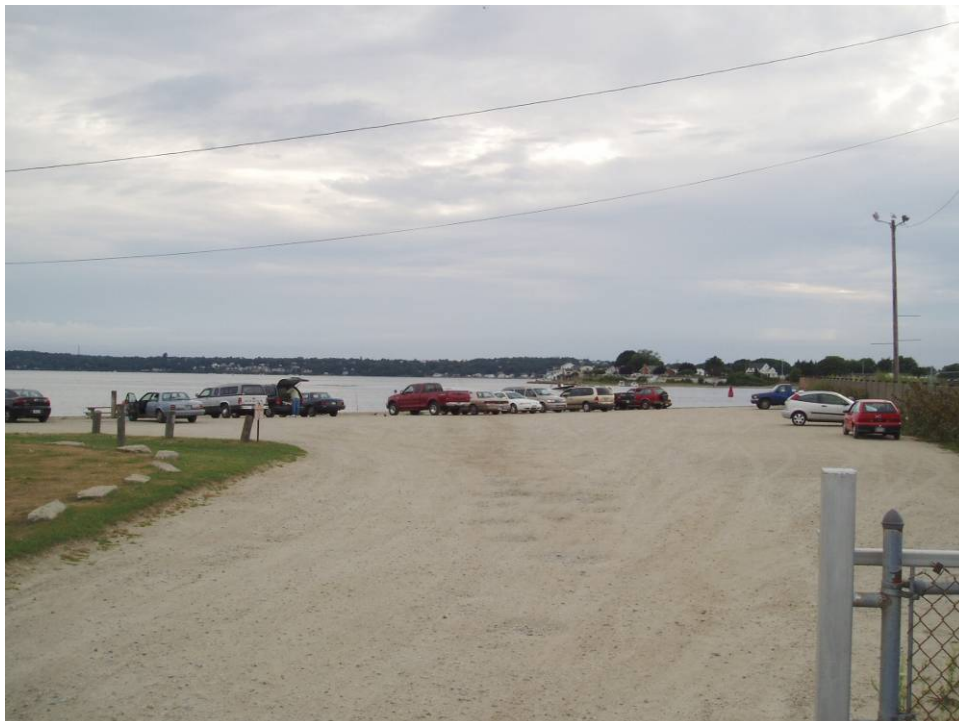
Fishing at the Stone Bridge Tiverton site is also inherently tied to Grinnell's Beach, as the beach parking lot offers ample capacity for both beach-going and recreational fishing uses (Photos 4, 7). While there is a nominal fee for parking at the site during lifeguard hours, fishing use of the site occurs primarily during the late afternoon / early evening hours when there is no fee for parking. Given that use of the bridge is prohibited, most anglers currently fish from the beach shoreline or the armor stone at the channel side of the abutment (Photos 7, 9). Beach and fishing uses appear to coexist well at this location; fishing at the site begins to increase in the evening just as beach use of the site begins to diminish after the end of lifeguard service at 4 p.m. The site is posted at the parking lot entrance as closed from ½ hour after sundown until sunrise, though regulars of the site noted that this is not always stringently enforced.

Photo 4. Grinnell's Beach parking area looking west from the entrance.

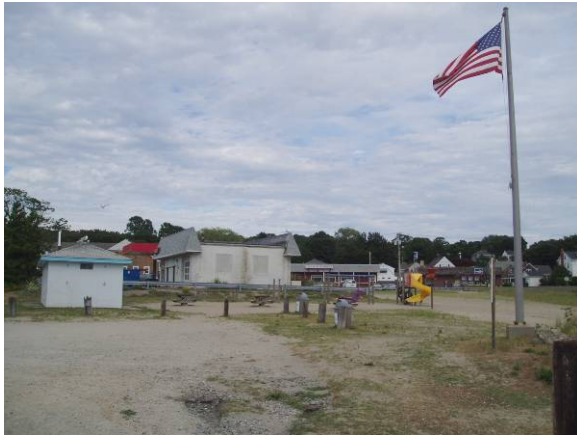
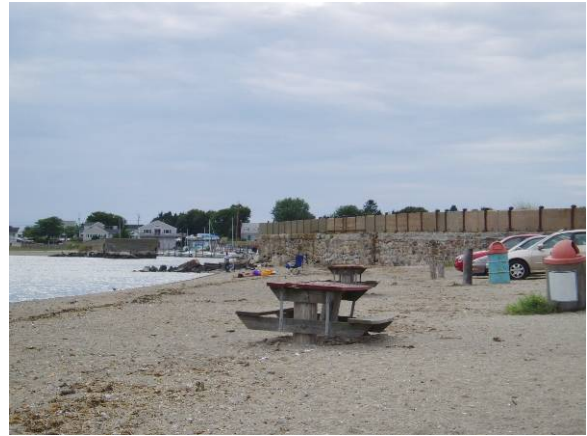
While currently exhibiting poor site aesthetics, the beach/park site does provide some amenities conducive to fishing, including picnic benches along the beach, several trash receptacles, ample shoreline to fish from, and parking immediately adjacent to shoreline fishing spots (Photos 5A, 5B, 7). Though no accessibility features are currently in place, one disabled angler interviewed at the time of site visit spoke favorably of the beach fishing area and its ease of handicap

usability (at-grade with the adjacent parking lot, minimal obstructions, etc.). A small restroom building is located on site (Photo 5B), however these facilities are open only during lifeguard hours.

Photos 5A and 5B. Grinnell's Beach facilities, including restrooms and playground (left), benches and trash receptacles (right).

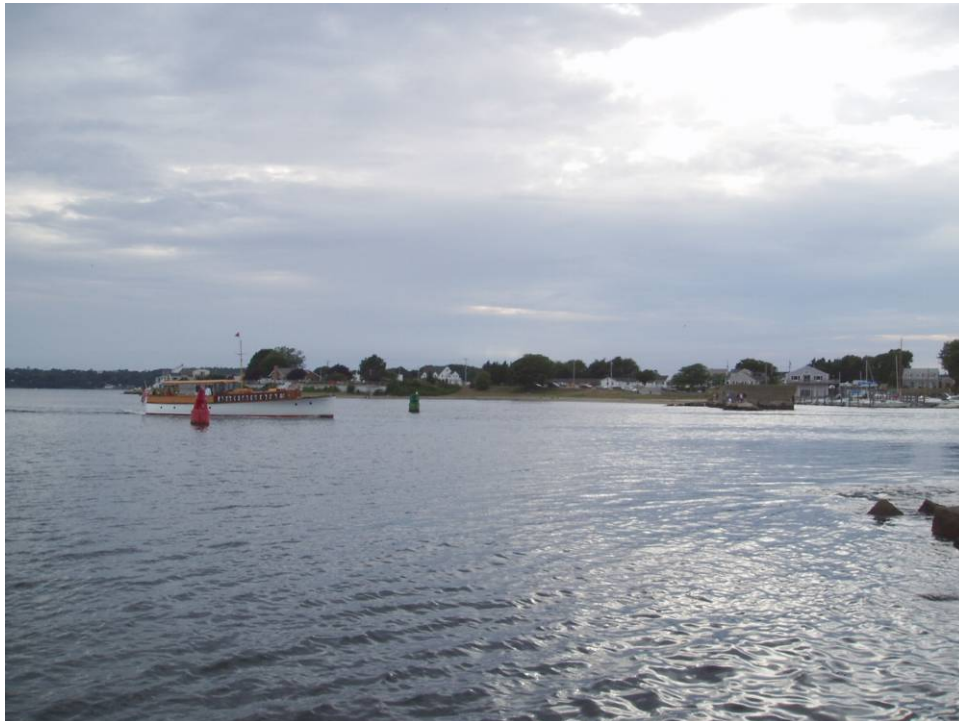
Photo 6. Navigation through Stone Bridge Channel. The west abutment in Portsmouth (background right) offers similar shoreline fishing opportunities.

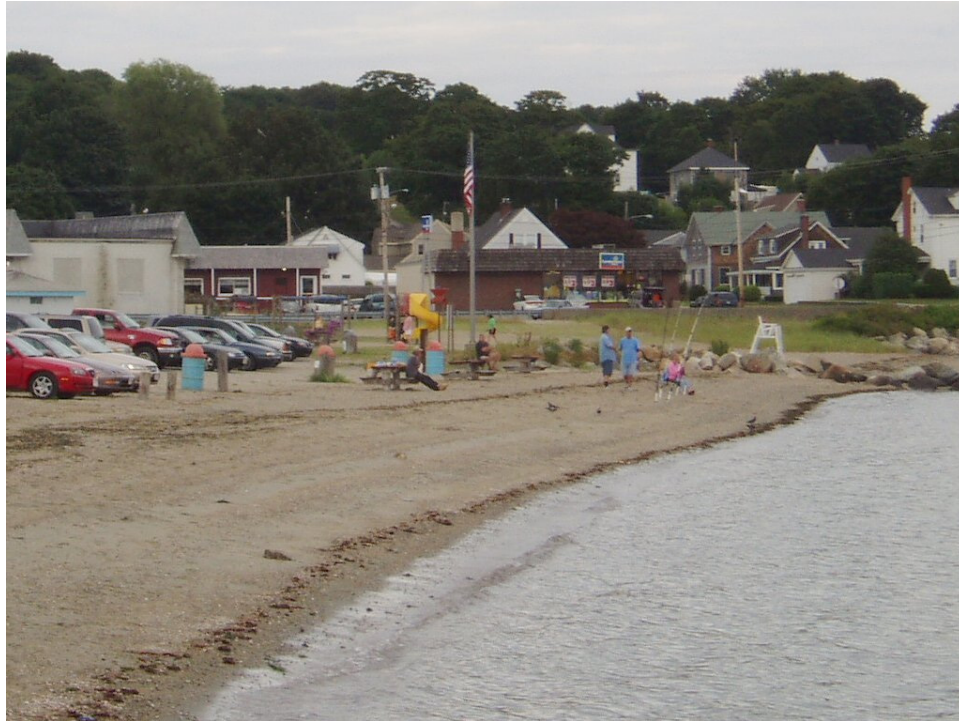
Photo 7. Evening fishing along Grinnell's Beach looking southeast.

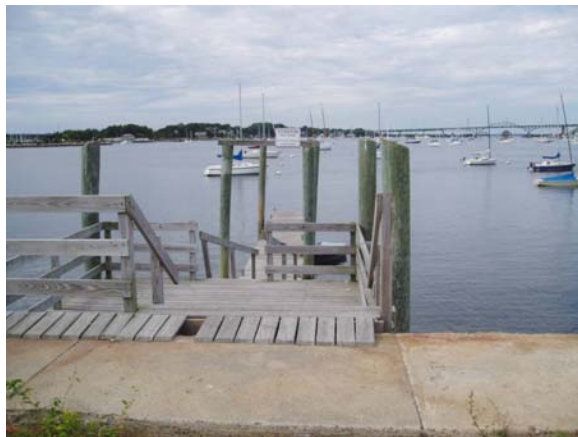
Photo 8 (left). Tiverton Town Landing and mooring area along northerly side of the bridge abutment. Fishing from this structure is prohibited.

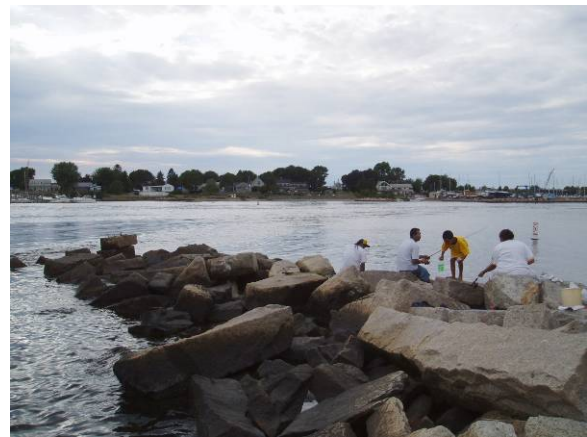
Photo 9 (right). Fishing along armor stone at the channel end of the bridge abutment.
